STUDY AND ANALYSIS OF FRACTURES IN GEARS FROM AUTOMOTIVE TRANSMISSIONS

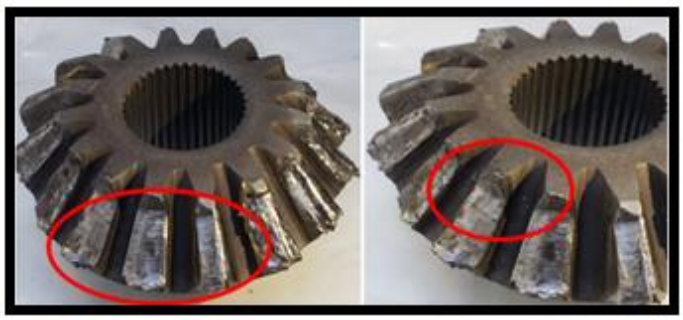
Figure 2 - Gear teeth Breakage Because to Flexing Fatigue.

The fracture of a gear tooth due to flexion fatigue has a surface as shown in figure 2, and some specific characteristics such as:

• Origin of crack in the tooth’s root is on the side where the loading occurs;

• The crack appears first in the middle of the tooth’s loading face;

• The material does not have any metallurgical flaws present, being in accordance with the specifications.

Breaks occur due to the growth of these cracks, being more frequent when the focal point, where the crack originates, coincides with a stress concentrator of edge that is present in the rounding radius of the tooth’s root. After a rupture due to flexion fatigue, there is another rupture due to an overload in the teeth next to the broken tooth, this happens because, even with one or two broken teeth, the gear remains in operation increasing the shock between the teeth. As we can see in the figure 2 below.

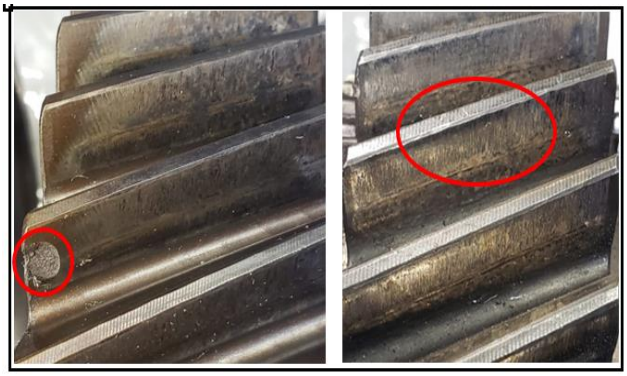
Figure 5 - “Scoring” Destructive Initial.

This failure, unlike fatigue, can occur with low loading cycles, often associated with lubrication problems, such as: absence of oil film on the tooth surface, low viscosity, etc.

Scoring is characterized by scratches and scrapes, and the greatest occurrence is in contact between the top of the crown and the nose of the pinion, the lower region of the pinion, the upper region of the crown and counting the top of the pinion with the crown root.

It occurs mainly in gears that operate at high speeds like automotive ones, and is influenced by the materials used and their tempera. Affinity materials can fuse in contact teeth and pinions with surface hardness higher than crowns increase the resistance to this type of failure in the figure 5 illustrates an initial scoring.

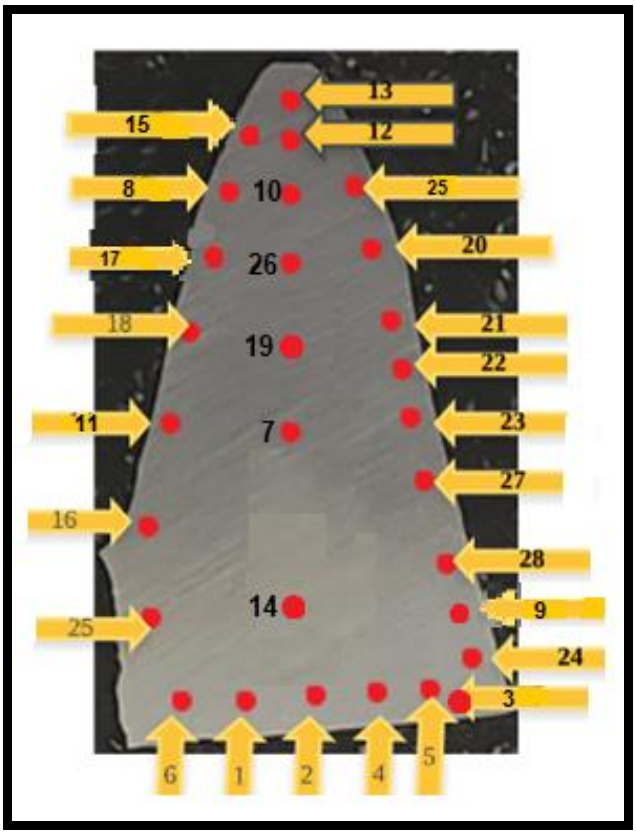
Figure 9 - Representation of Rockwell Hardness Test Points (HRC).

For this project the Rockwell test was used in a Panambra, equipped with a conical diamond penetrator and a load of 150 kgf, to test a gear tooth of the 4th gear of a Mercedes Bens that had fractured losing 6 teeth. The test was performed with 28 measurements on the contour, on the root and also from the upper end of the tooth to the root through the center of the tooth. The average of the measurements was 55 HRC, the lowest reading being 30 HRC on one side of the tooth root and the highest reading was 62 HRC at two points on the same edge of the tooth in the carbonitriding region, one being close to the root and the other close to the center of the tooth. In table 2 and in the figure 9 we can see some points where the hardness test was performed and the values obtained in the test.

Results of Hardness Test HRc			
1.) 46 HRc	2.) 56 HRc	3.) 58 HRc	4.) 59 HRc
5.) 55 HRc	6.) 42 HRc	7.) 42 HRc	8.) 53 HRc
9.) 56 HRc	10.) 49 HRc	11.) 57 HRc	12.) 47 HRc
13.) 56 HRc	14.) 20 HRc	15.) 51 HRc	16.) 54 HRc

17.) 62 HRc	18.) 62 HRc	19.) 41 HRc	20.) 51 HRc
21.) 59 HRc	22.) 60 HRc	23.) 61 HRc	24.) 57 HRc
25.) 57 HRc	26.) 49 HRc	27.) 51 HRc	28.) 58 HRc

According to the studies of Castro (2005), The surface hardness of automotive gears is around 60 HRC and the core hardness is 30 HRC. Values very close to those found in our measurements, and also corroborated by the characteristics of SAE 5120 steel.
